Manhole Inspection Summary

Manhole # S13GG_045MH

Insp Date: **7/21/09 11:32 AM**

Location Address: **2759 BAKER ST**

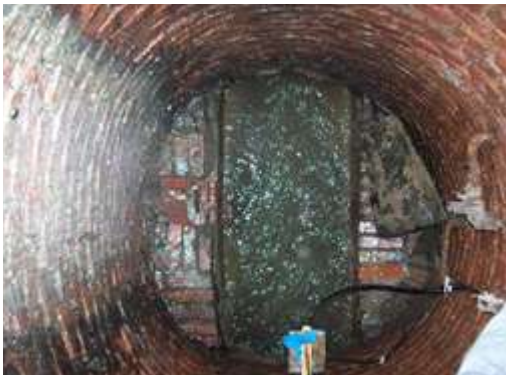
Defect 1

Count: **6** Missing: **2** ☒ **Corroded**

corroded steps

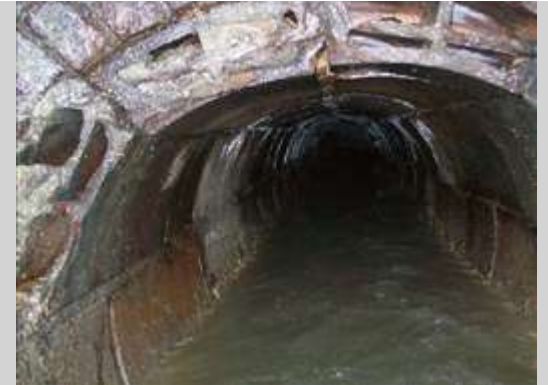
12 O'Clock Outflow

27 in. Circular Gravity Sewer
Pipe Out @ 12 O'Clock

Pipe Height: **33.6** (in.) Rod Only (Angled)
Pipe Material: **Clay** ☐ Pipe Lined
Invert Depth: **19.78** (ft.) Flow Characteristics: **Fast**
Deposits: ☒ None ☐ Mud ☐ Sludge ☐ Debris ☐ Grease
Silt Depth: (in.) Deposits Extent:
Infiltration: **None** Pipe Seal Cond: **Sound**

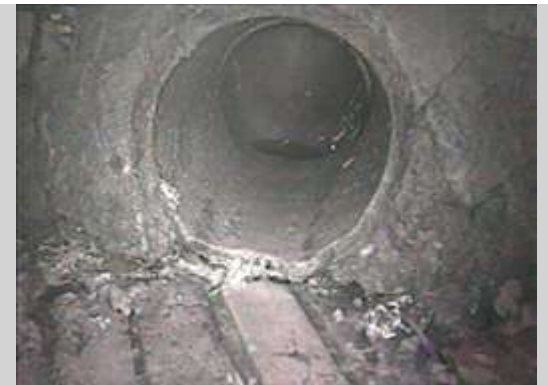
3 O'Clock Inflow

8 in. Circular Gravity Sewer
Pipe In @ 3 O'Clock

Pipe Height: **7.2** (in.) Direct
Pipe Material: **Clay** ☐ Pipe Lined
Invert Depth: **16.50** (ft.) Flow Characteristics: **Slow**
Deposits: ☒ None ☐ Mud ☐ Sludge ☐ Debris ☐ Grease
Silt Depth: (in.) Deposits Extent:
Infiltration: **None** Pipe Seal Cond: **Sound**

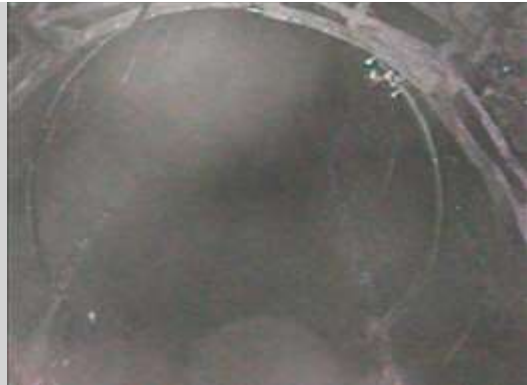
6 O'Clock Inflow

Pipe In @ 6 O'Clock

Infiltration: **None** Pipe Seal Cond: **Sound**

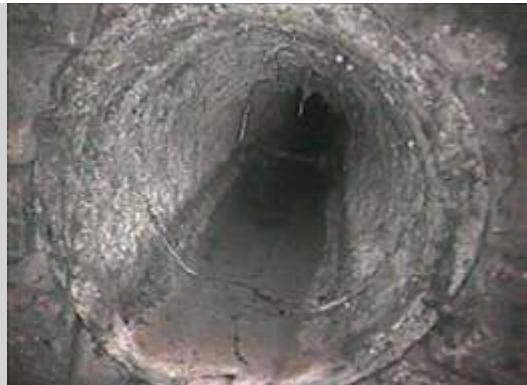
9 O'Clock Inflow

Pipe In @ 9 O'Clock

Infiltration: **None** Pipe Seal Cond: **Sound**

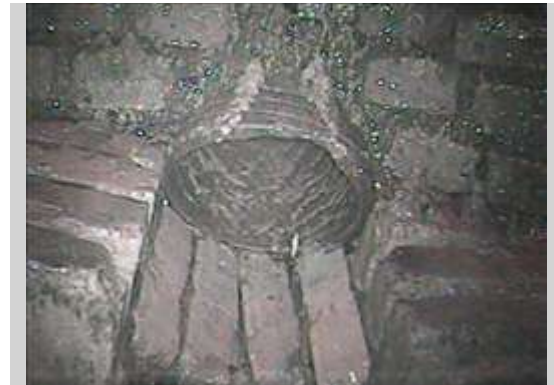
Drop In @ 9 O'Clock

Drop: **Outside Direct**

Drop Condition: **Open**
